Do the CONTEC CMS8000 Patient Monitors Contain a Chinese Backdoor? The Reality is More Complicated...

By Team82

Published: 2025-02-02 · Archived: 2026-04-05 17:50:01 UTC

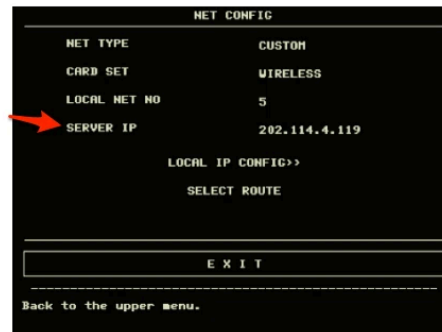
Figure 3-23 NET CONFIG

CMS: the Server IP is fixed, "202.114.4.119"; "LOCAL IP CONFIG" is unavailable.

The Contec manual recommends the CMS hardcoded IP address: 202.114.4.119.

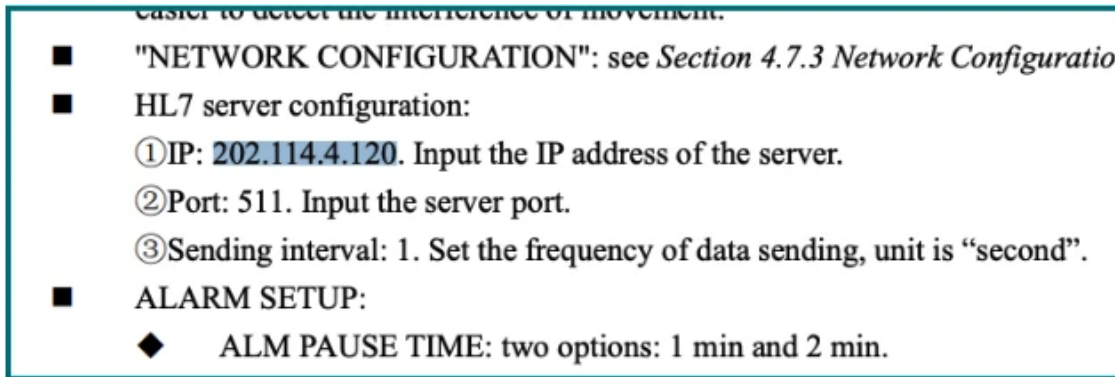
In addition to 202.114.4.119 , another hardcoded IP address is used: 202.114.4.120 inside the firmware of the patient monitor. This IP address, also part of the routable subnet 202.114.4.0/24 , is used by the patient monitor as a central HL7 server over TCP/511. The HL7 server allows the patient monitor to communicate and share the patient data it collects (heart rate, blood pressure, oxygen saturation, etc.) with other systems across the hospital. Once again we see that the vendor used a routable public IP address for this critical function handling sensitive patient information, which could lead to potential patient information leakage.

Part of the CMS8000 configuration, showcasing the default hardcoded HL7 server.

- If not using the HL7 capabilities of the patient monitor, it is recommended blocking all network traffic outbound to `202.114.4.120` to prevent potential PII/PHI leakage.

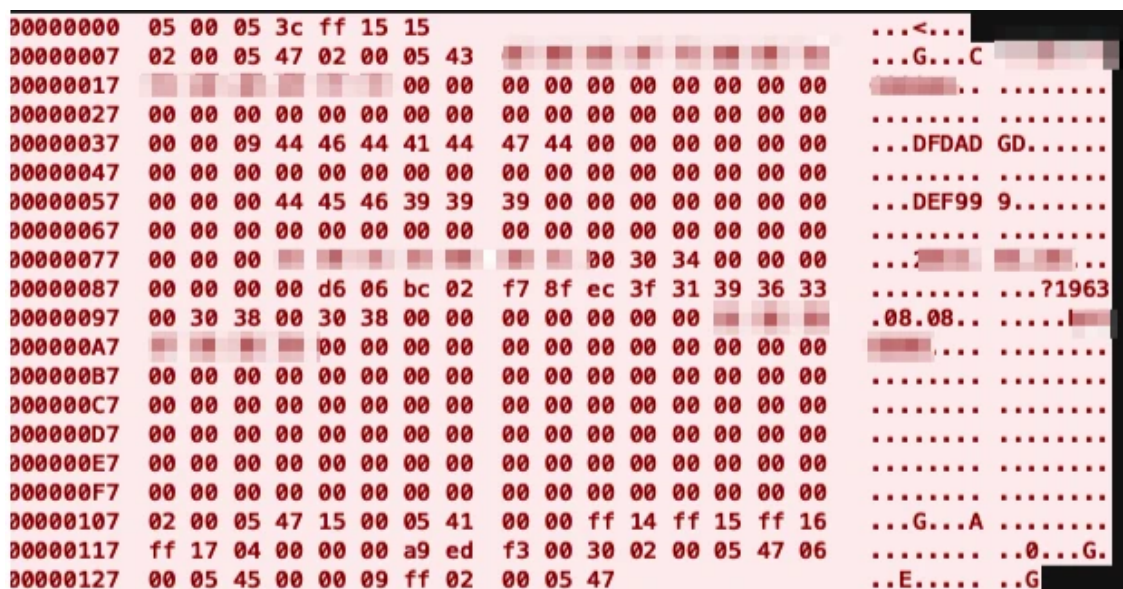
In addition to HL7, Contec implemented a protocol to communicate with the CMS over TCP ports 515-520. Below is an example of the patient monitor and CMS TCP communication over TCP port 515. We can see that patient information is transferred to the CMS server.

In order to block the patient monitor from reaching the public IP addresses it has hardcoded in its firmware, leaking PII, and potentially receiving malicious binaries, we recommend blocking the entire `202.114.4.0/24` subnet in outgoing network traffic on your firewall.

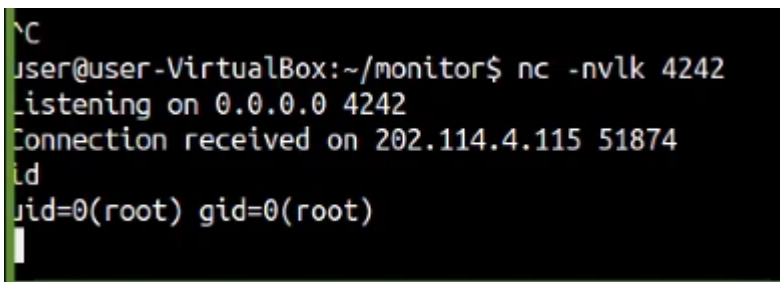
Our installed backdoor, giving us a reverse shell on the patient monitor in the root user's permissions.

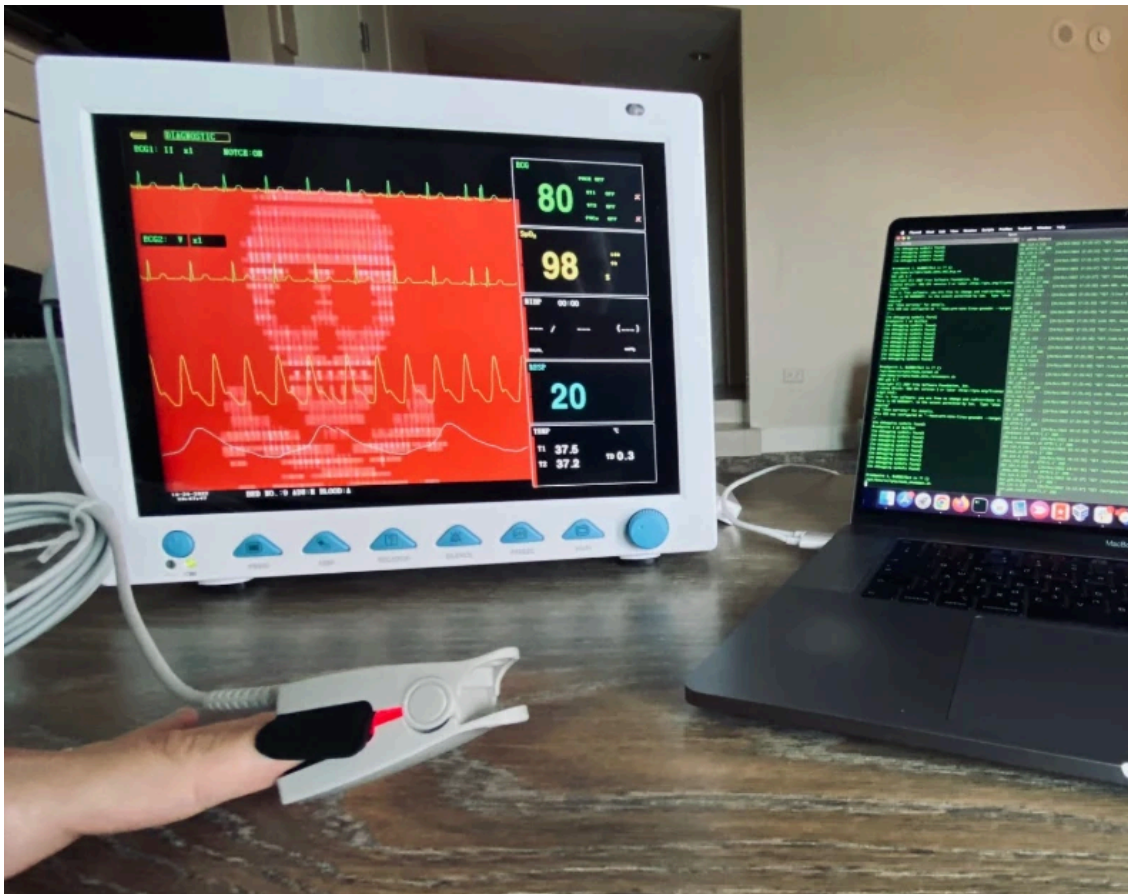
At Nexus Conference 2022, Team82 exploited this insecure design flaw and executed malicious code on a patient monitor.
