Unpacking the Blackjack Group's Fuxnet Malware

By Team82

Introduction

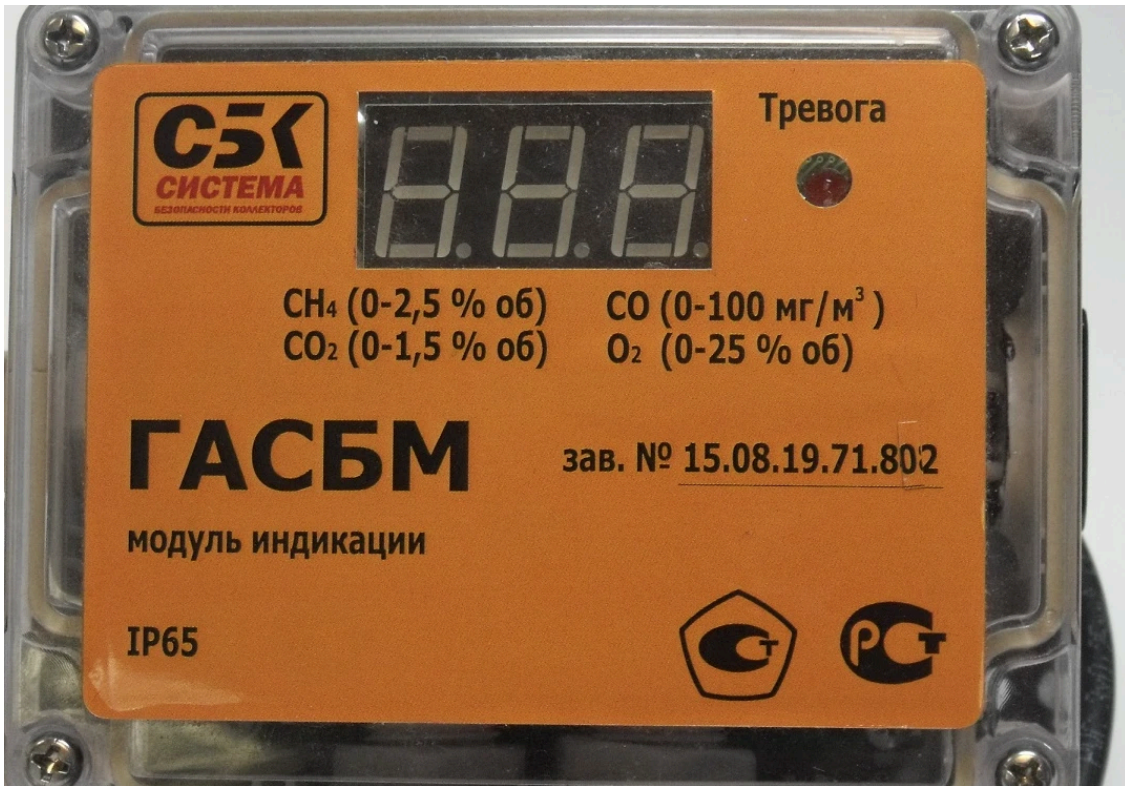
Gas analyzer of the security system (GASBM)

- **Gas analyzer of the security system (GASBM):** Designed for continuous automatic measurements of the volume of methane (CH₄), carbon dioxide (CO₂), oxygen (O₂) and/or mass concentration of carbon monoxide (CO) in the air of industrial and non-industrial premises (collectors, warehouses , etc.).

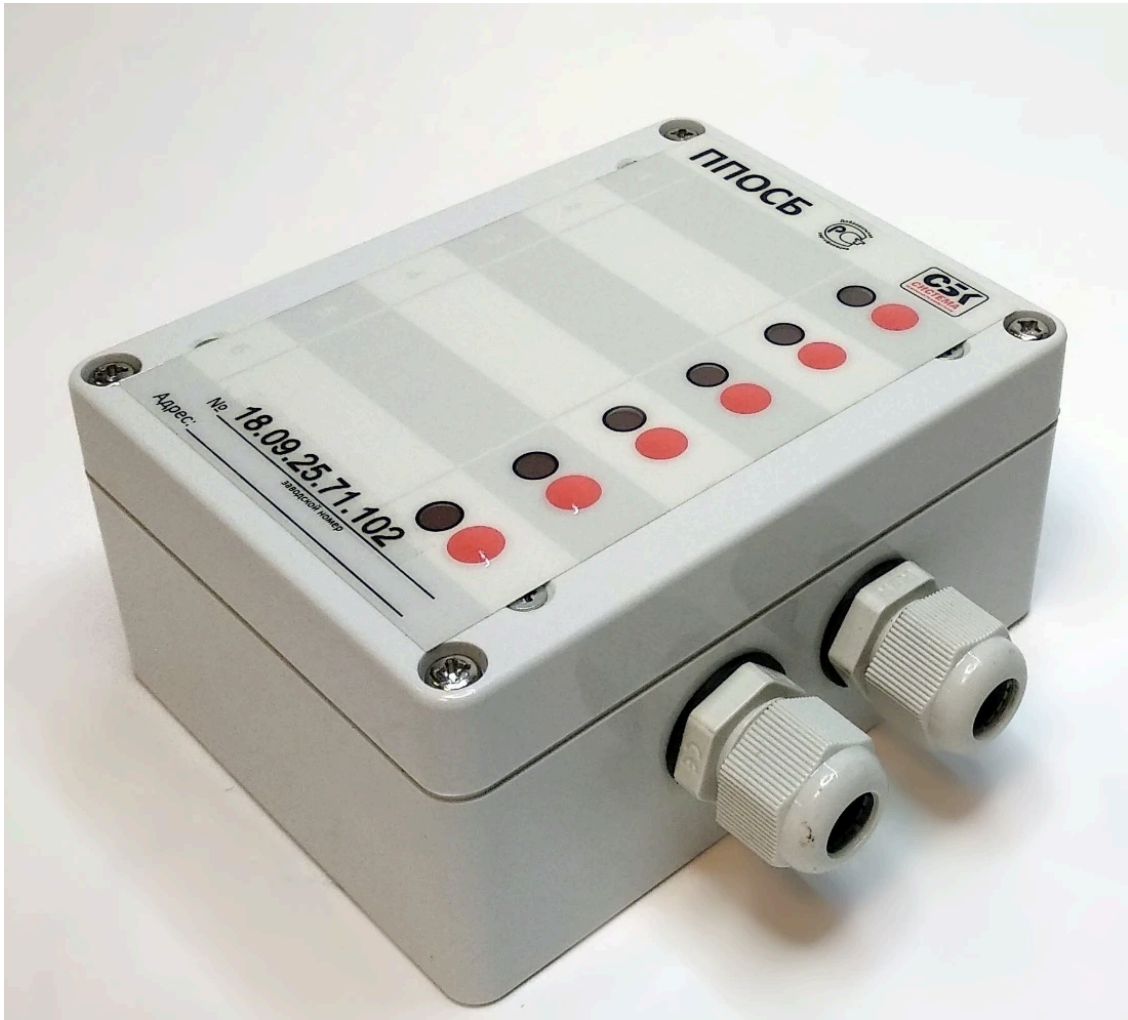
Fire and security system console.

- **Fire and security system console (PPOSB):** Activates an alarm when the sensors read signals of fire or smoke.

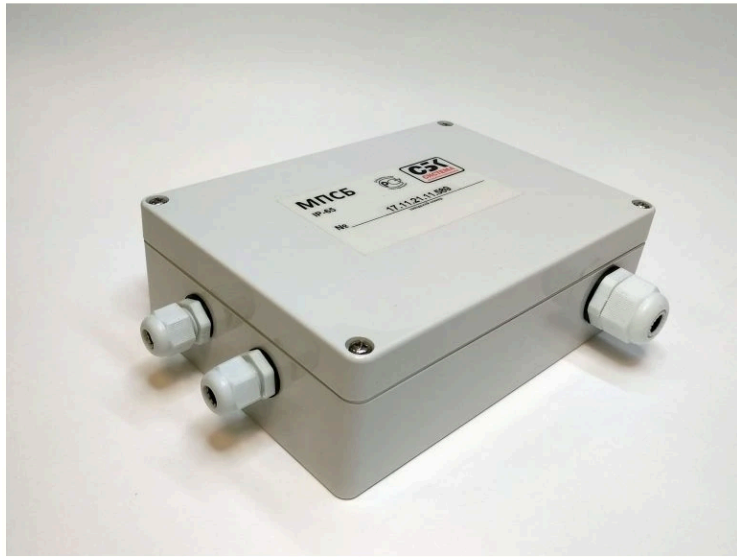
Data transmission module (MPSB)

Designed for information exchange with external devices through various interfaces.

MPSB is the middle level of the SBC system. Provides information exchange **with the upper level** of the SBK system via the **TCP/IP protocol via Ethernet 10/100 TX (IEEE 802.3)** and/or GPRS interfaces (using an external modem) and in accordance with the approved SBKHigh information exchange protocol.

The MPSB sensor gateway, designed for information exchange with external devices through various interfaces. It supports ethernet and serial communication protocols including CAN, RS-232, and RS-485.

- [MPSB](#): Designed for information exchange with external devices through various interfaces. It supports ethernet and serial communication protocols including CAN, RS-232, and RS-485.
- [TMSB](#): Similar to MPSB; includes a built-in 3/4G modem that enables it to transmit data over the internet to a remote system.

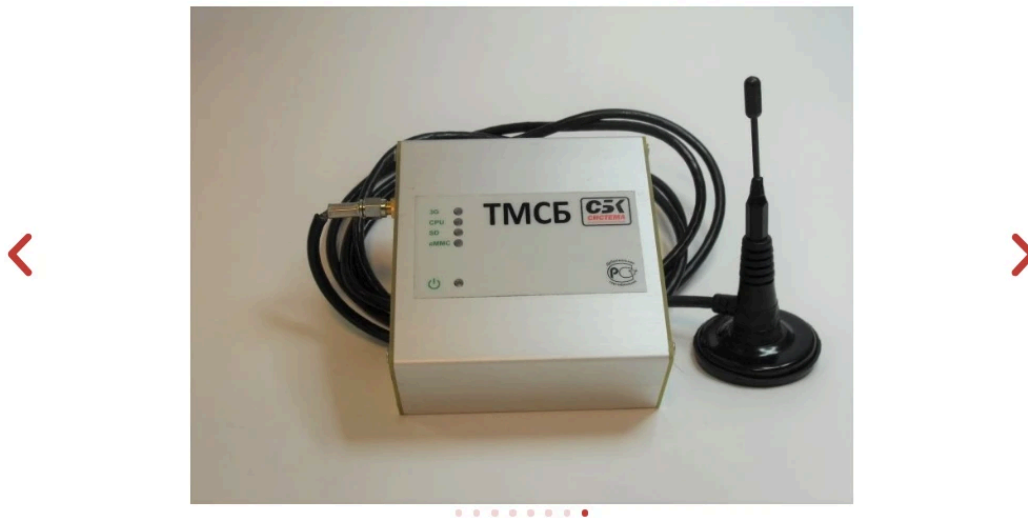
Telemetry module (TMSB)

Designed for collecting and transmitting data from networks of security and industrial automation devices.

A powerful Cortex A8 processor and 512 MB of RAM allow the device to solve a wide range of tasks in the field of Internet of Things (IoT) and industrial automation.

The module is equipped with a 3G/4G modem with operator redundancy and Ethernet, CAN, RS-232 and RS-485 ports. Communication capabilities allow the use of TMSB in geographically distributed systems, including when the Network is unstable.

The TMSB sensor gateway, similar to MPSB, and includes a built-in 3/4G modem that enables it to transmit data over the internet to a remote system.

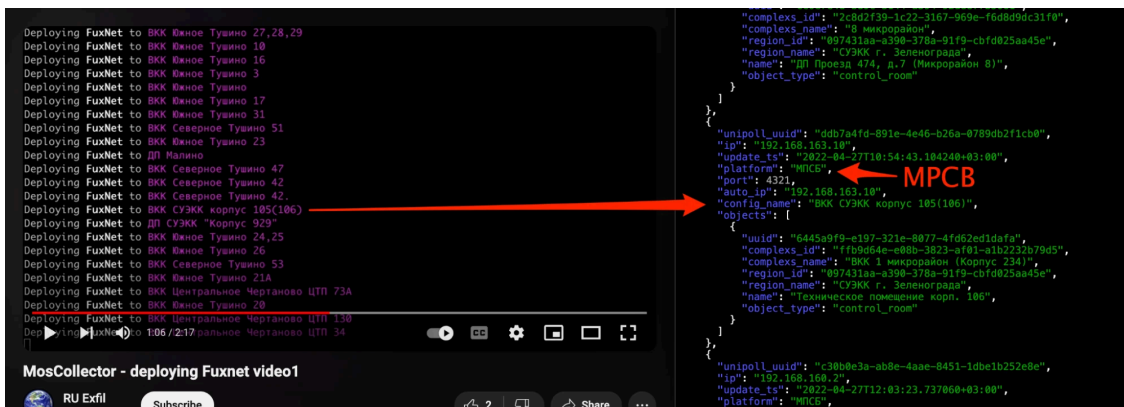
We correlated this information with two Youtube videos ([here](#), [here](#)) the attackers released showing the deployment of the Fuxnet malware. All of the listed devices from the videos matched the gateways from the JSON of the extracted devices, which confirms our assumption that only the TMSB/MPSB gateways were attacked with Fuxnet.

Correlating attacked devices with the sensor gateways from the leaked extracted JSON file

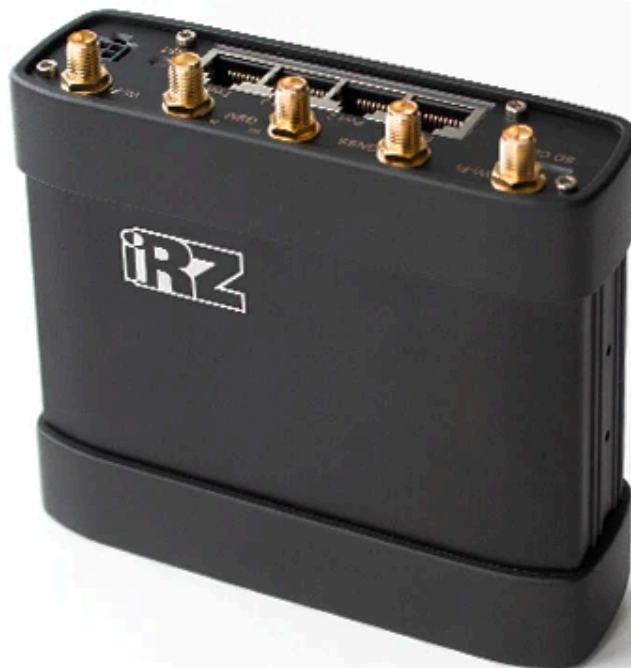
An IRZ RL22w, the 3G router attacked by Blackjack.

These routers were likely used as internet-gateway devices, allowing the sensors to be easily internet-connected. By connecting a SIM card to the router, and using its 3G capabilities, it can allow remote sites to connect to the internet.

While there are some publicly known vulnerabilities for IRZ 3G routers, they do not enable zero-click remote code execution. Instead, the attackers chose to use the SSH service to connect to these IoT devices and tunnel to internal devices, probably after obtaining the root passwords for these devices. Eventually, the attackers were able to gain full access as shown in the screenshots they released.

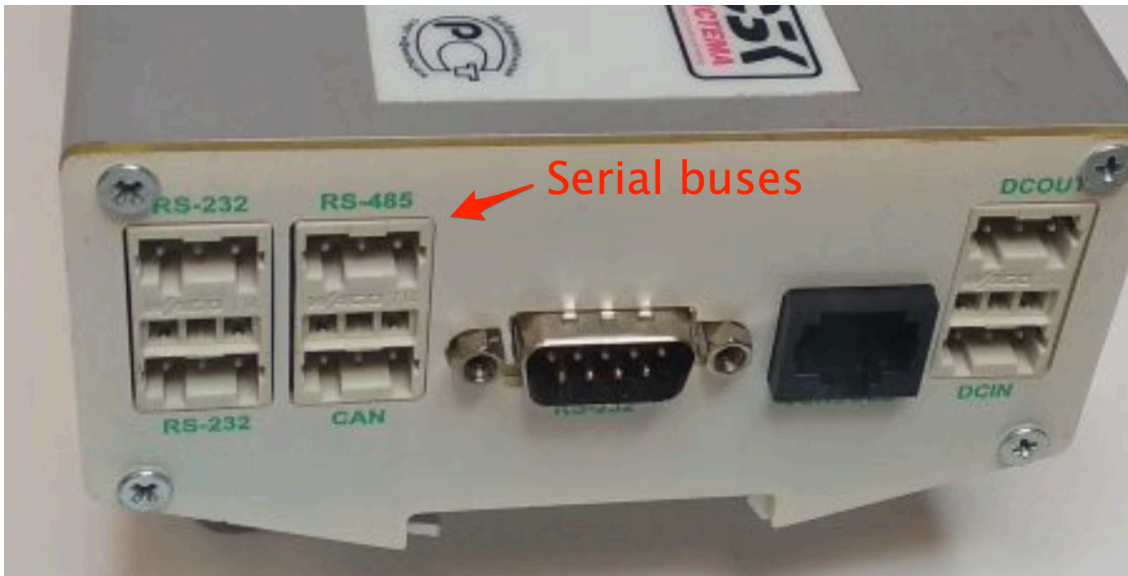
A look at the serial ports on the TMSB gateway. Sensors will be connected behind these ports. The malware will try to flood these ports with unknown packets.

The malware tries its best to disrupt the sensors behind the gateway by flooding the serial channels with presumably random data, effectively overloading the serial bus and the sensors.

During the malware operation, it will repeatedly write arbitrary data over the Meter-Bus channel. This will prevent the sensors and the sensor gateway from sending and receiving data, rendering the sensor data acquisition useless. Therefore, despite the attackers' claim of compromising 87,000 devices, it seems that they actually managed to infect the sensor gateways only and were trying to cause further disruption by flooding the Meter-Bus channel connecting the different sensors to the gateway, similar to network fuzzing the different connected sensor equipment. As a result, it appears only the sensor gateways were bricked, and not the end-sensors.

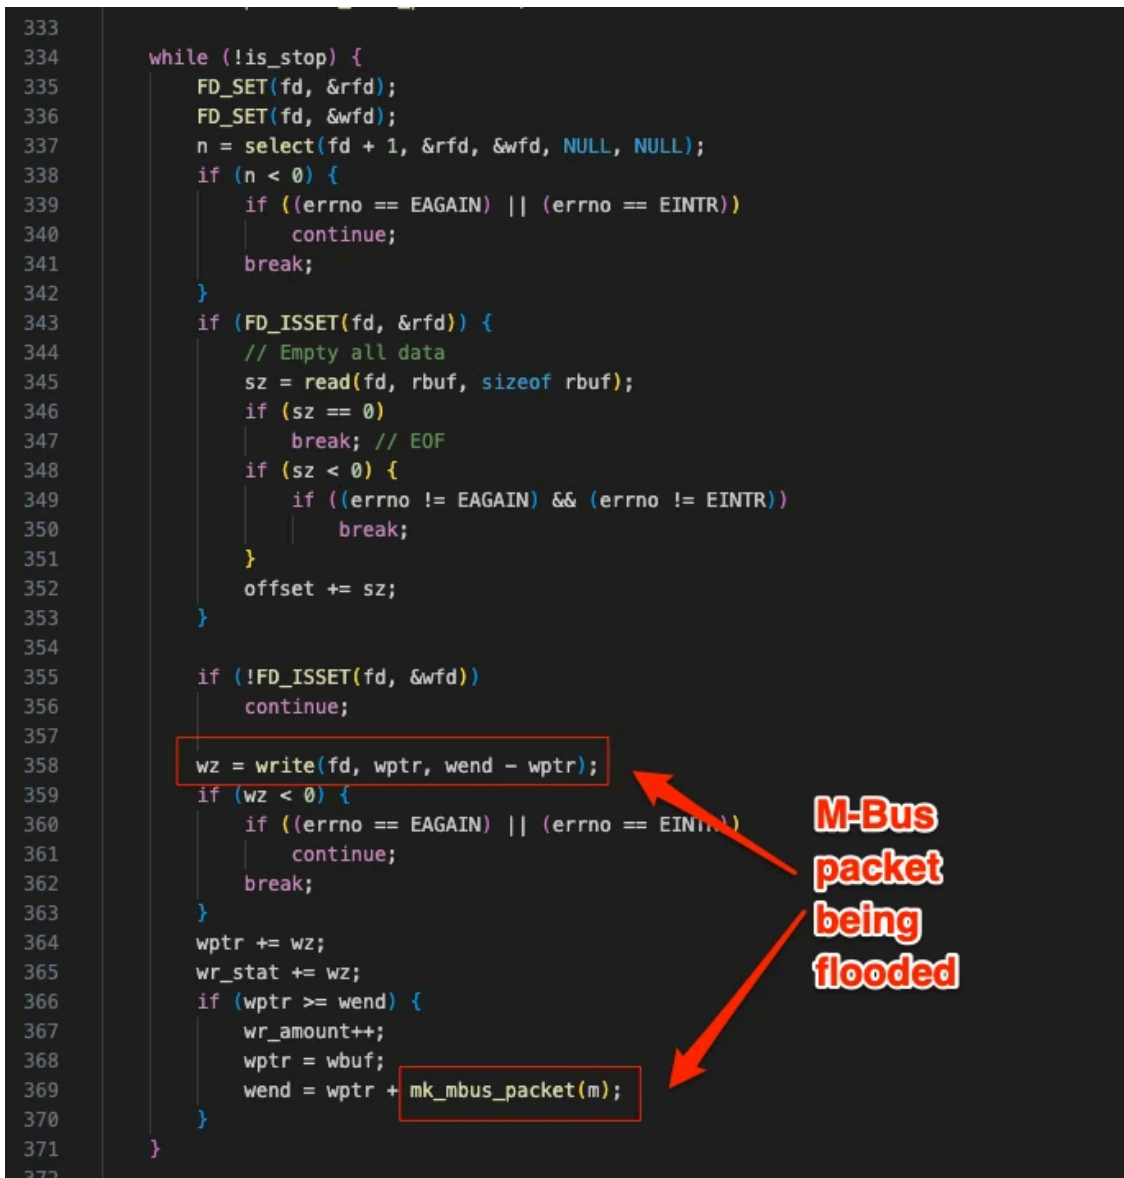
A screenshot released by the attackers, flooding the M-Bus bus with packets.

We inferred that the attackers tried to overwhelm the bus channel with the amount of frames they were sending, in order to disable sensor communication over that channel. It seems like the attackers wanted to both flood the serial channel and also potentially trigger a bug or vulnerability in the sensors that would damage them.
